PART I: SEPTEMBER 11, 2001

Chapter 1

NEW YORK CITY'S WORLD TRADE CENTER

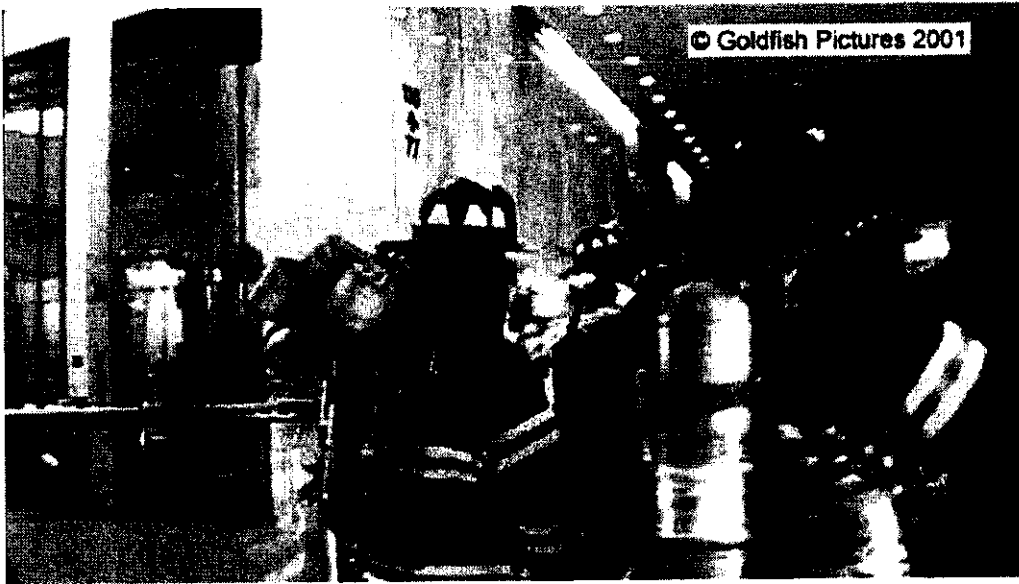
Figure 2-6. Firefighters on the scene at about 9:07 a.m.

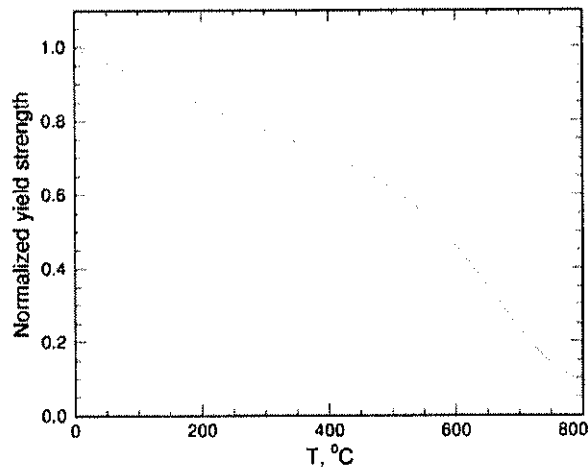
Figure 2-9. Temperature dependence of yield strength of structural steel as a fraction of the value at room temperature.
